സംസ്ഥാന ദുരന്ത നിവാരണ അതോറിറ്റിയുടെ ഉരുൾപ്പൊട്ടൽ ഉപദേശക സമിതി പഠന റിപ്പോർട്ട്

**A report on the landslide studies at Kodasseri Panchayat,
Thrissur District**

Investigated on 06-01-2022

**Kerala State Emergency Operations Centre (KSEOC)
Kerala State Disaster Management Authority (KSDMA)**

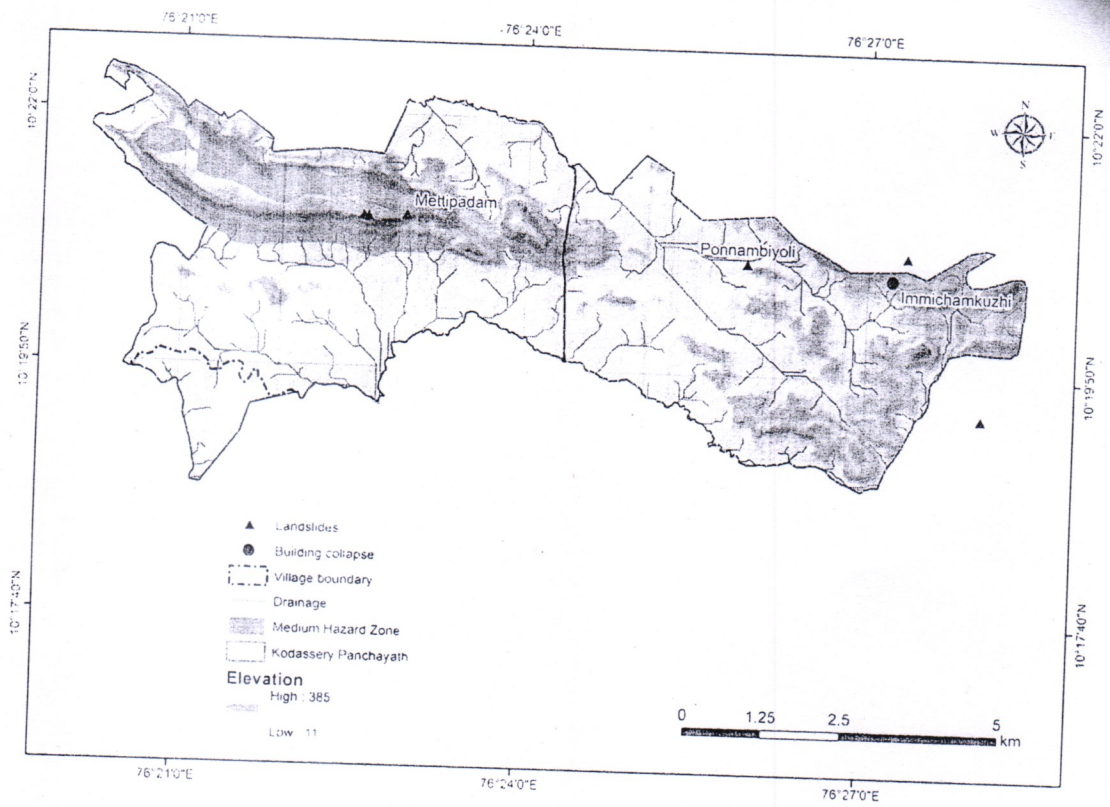
Administratively, Kodasseri panchayat encompasses Kodasseri village and parts of Kuttichira, and Azhikode villages. Physiographically, this area forms a part of the midland system of the state. But this panchayat is characterized by a linear hill, running roughly in an E-W direction, with a maximum elevation of 386 m, mimicking a highland region (Fig. 1). This hill occupies an area of 7.3 km² compared to the 48.94 km² area of the panchayath. The slope of the hill varies from 0 to 47.7°, with an average of 22.3°. Usually, areas having a slope of >20° are considered susceptible to landslides (Fig. 2). Other than these linear hills and their associated hillocks, the entire area is generally plain. The landslide susceptibility map of NCESS depicts this hill as medium susceptible (Fig. 3).

Fig. 3 Landslide susceptibility map of Veetoor area. Note the low susceptibility of this area

- 1) The plots with survey numbers that overlie the medium-susceptible zone of the landslide susceptibility map of KSDMA will be treated as no construction zone.

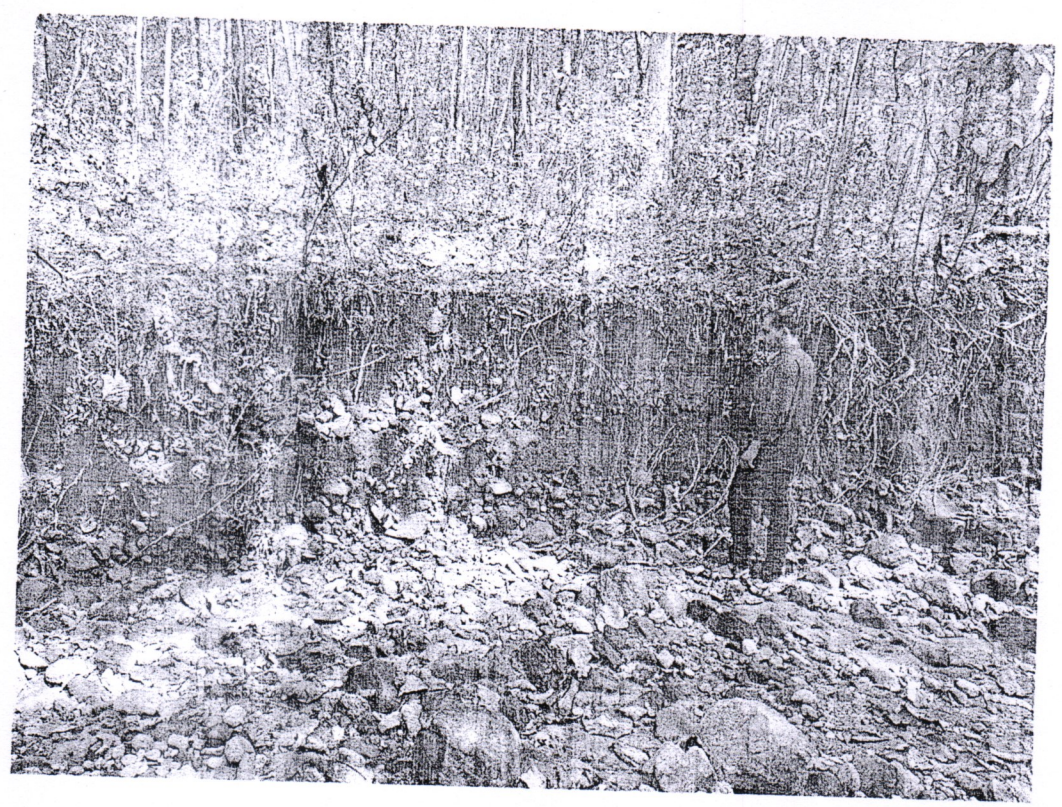
Immichampuzhi ($10^{\circ}20'58''\text{N}$, $76^{\circ}22'36''\text{E}$). This house is located exactly on a stream course, blocking the normal course of the river. There is no culvert where the stream crosses the road. The other landslide that occurred outside area has previous history of landslide activity. The stream through which the debris was confined shows successive layers of random boulders that confirm the previous landslide activity (Fig. 4). All five landslides and their runout are visible in the high-resolution Google Earth images. The Google Earth image of these three landslides that occurred within the panchayat is shown in Fig. 5. Those are Mettipadam ($10^{\circ}21'7.87''\text{N}$, $76^{\circ}22'36.66''\text{E}$), and the other two unknown location with coordinates $10^{\circ}20'8.16''\text{N}$, $76^{\circ}22'36.66''\text{E}$ and $10^{\circ}21'8.53''\text{N}$, $76^{\circ}22'56.42''\text{E}$.

Fig. 4 The steeply eroded seasonal stream with its dried bed. The banks show successive boulder deposits, suggesting previous landslide activity

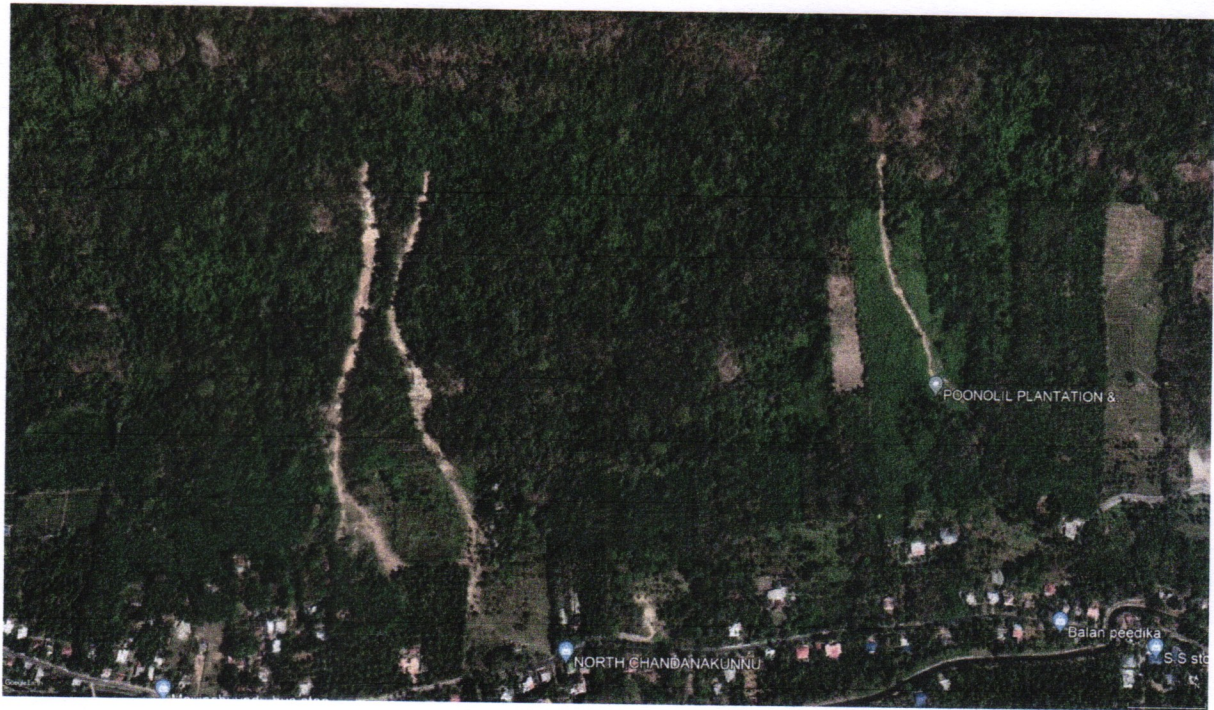
These three landslides that occurred in this panchayat have similar characteristics, with a length spanning from 332 to 578 m and a width ranging between 4 and 20 m. The crowns of these three landslides are at the same elevation (~210 m), and situated just below the barren rocky outcrops of hornblende biotite gneiss. Hence, during the monsoon, all the water in the crown part has surcharged the immediately downslope lying column of lateritic soil, causing an increase in pore-water pressure. All these landslides are confined to first-order seasonal drainage originating from this hill. According to the local people, the forest authorities have blocked the streams at an intermittent distance for the stagnation of water for wild animals. The dislodging of the construction material of these 'check dams' increased the volume of landslide debris.

Fig. 5 High-resolution Google Earth image showing the three landslides that occurred in this panchayat. Note the long runouts that end just beneath the foothills

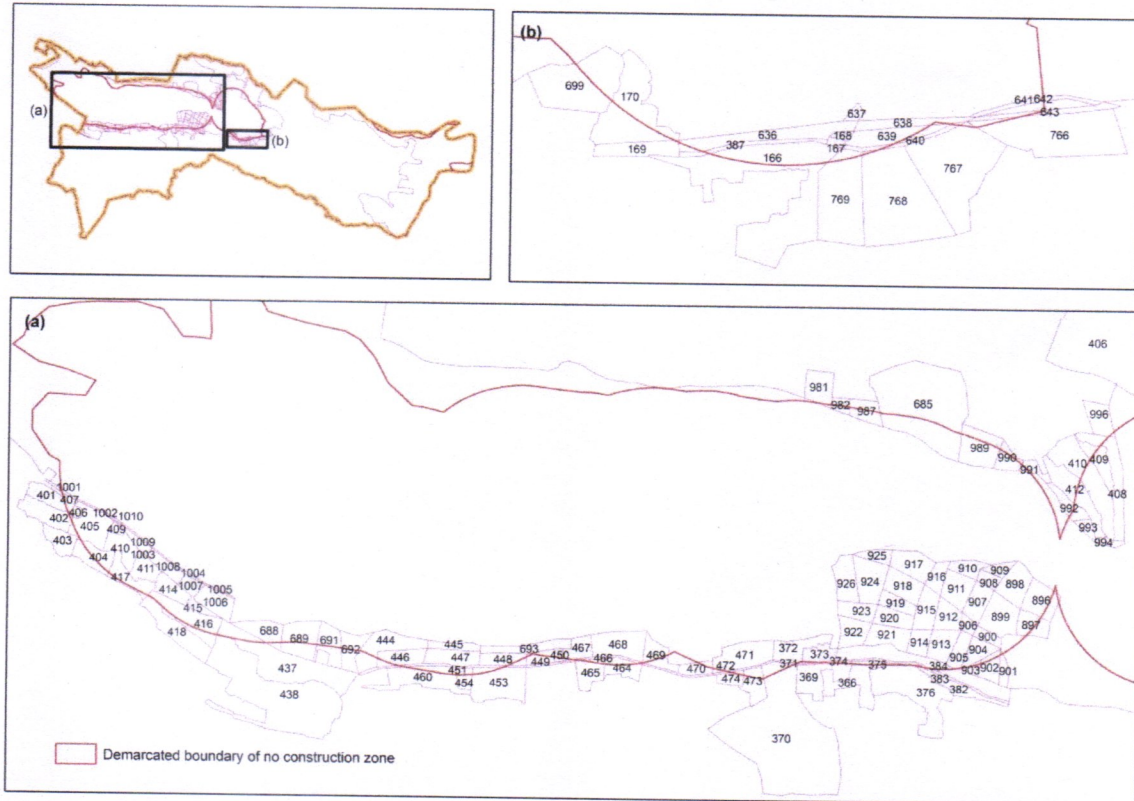
Fig. 6 Map showing survey numbers of plot in the buffer zone, which is tentatively considered as 'No Construction Zone'.

- 2) Since the landslide susceptibility map of the study area is not exactly matched with the raster image of the study area, an alternate method is also incorporated. Considering the maximum runout length of the landslides that occurred in this area was 578 m, a length of 600 m from the barren outcrop of the hill or the crest line of the hill in the absence of barren outcrop of rock was taken as a buffer and plotted on the Digital Elevation Map (DEM). The land holdings with survey numbers that overlie this zone will also be treated as no construction zone.

- 3) Thus, plots with survey number either in any of these zones is considered as 'No Construction Zone'. And it comes to about 9.23 km².
- 4) Since, this is a preliminary study, a detailed landslide susceptibility mapping is suggested, so that precise locations prone to landslides can be demarcated.
