ചാലക്കുടി മേഖലാ ശാസ്ത്ര കേന്ദ്രത്തിലെ പ്ലാനറ്റേറിയത്തിന്റെ നവീകരണം

STRUCTURAL STABILITY REPORT

of

Planetarium Building,
Chalakkudy

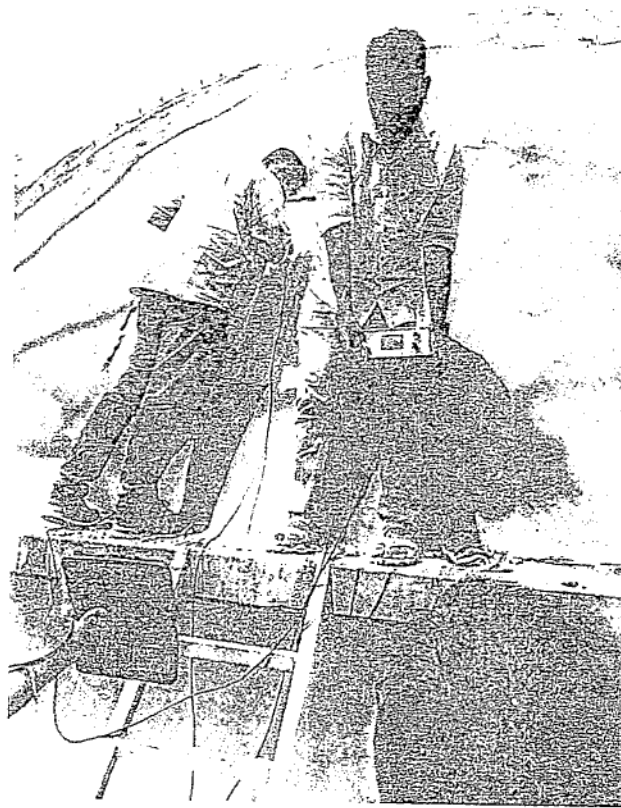
Fig 4. UPV Test

Sl. No:	Location	Point	Structural Element	Average Pulse Velocity (km/sec)	Concrete Quality Grading	Procedure
On the top of Dome						
1	E2	A	Slab	4.2	Good	Surface Probing
2		B	Slab	3.4	Medium	Surface Probing
3	E4	A	Slab	3	Medium	Surface Probing
4		B	Slab	3.8	Good	Surface Probing
5	E7	A	Slab	4.1	Good	Surface Probing
6	E6	A	Slab	4.4	Good	Surface Probing
7	E10	A	Slab	3.5	Medium	Surface Probing
Inside the Building						
8	Location 1	A	Slab	4	Good	Surface Probing
9	Location 2	A	Slab	3	Medium	Surface Probing
10	Location 3	A	Slab	4	Good	Surface Probing
11		B	Slab	3.9	Good	Surface Probing
12		C	Beam	3.7	Good	Direct Transmission
13	Location 4	A	Slab	3.2	Medium	Surface Probing
14		B	Slab	3.9	Good	Surface Probing
15		C	Beam	4.1	Good	Direct Transmission

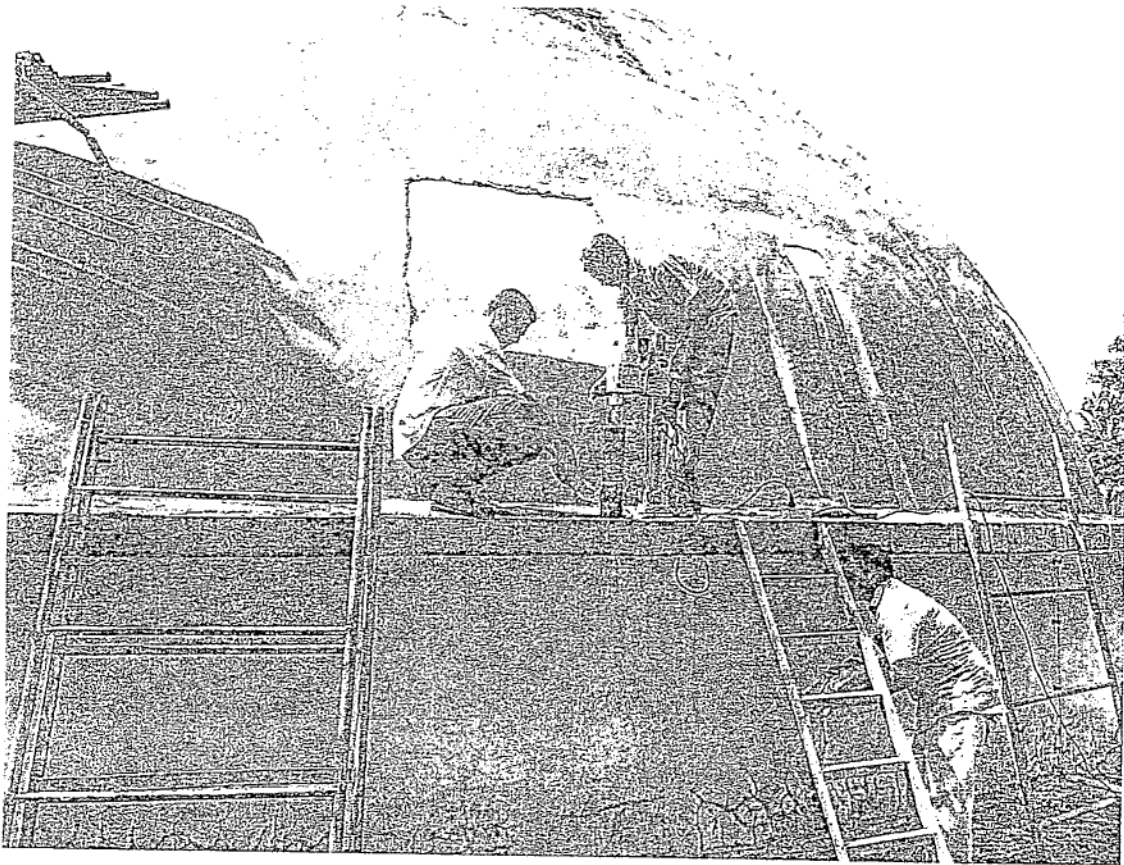
Fig 5. Taking Concrete Core Samples

Two Concrete core samples were taken from the projecting slab outside the dome (points E8 and E9). Compression tests were carried out on the Concrete Core Samples and the results are presented below

Sl. No:	Point	Corrected Compressive Strength (MPa)	Compressive Strength from Rebound Hammer Test (MPa)
1	E8	24.32	24.00
2	E9	24.19	24.00

The results of Compressive strength of concrete obtained from Rebound Hammer Tests and compression tests on Concrete Core samples taken are in good agreement with each other.

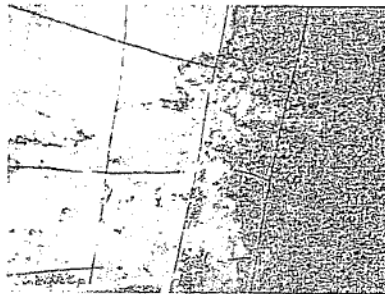
It was observed that there is seepage of water at certain locations through construction joints in the dome slab.

Fig 6. Construction joint in dome slab through which seepage of water is observed

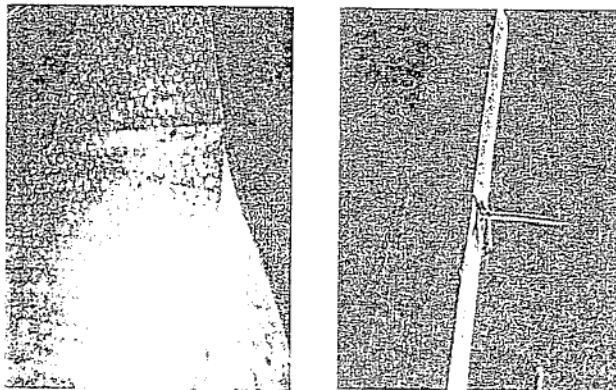
It is also observed that a layer of glass wool has been fixed on the bottom surface of slab of the dome using GI mesh and wooden reepers. The wooden reepers have been fixed to the bottom surface of the slab with screws, which penetrated into the slab for about 75 mm. The spacing of these screws is about 45 cm both ways.

Fig 7: Screws used for fixing the Glass wool layer

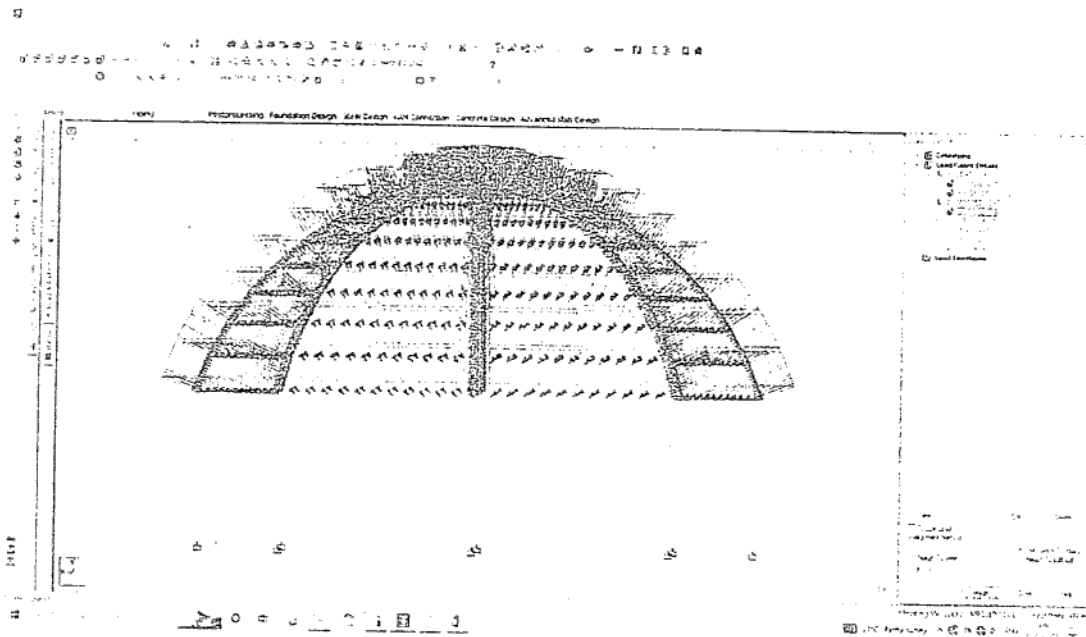
Fig 6. Numerical Analysis

Numerical analysis was carried out using the STAAD Pro Software and the design was checked. The dome has been modelled with the additional elevation of 1.5m as observed in the structure. The slab of the dome is modelled with the properties of M20, Radial Beams with M15, Ring Beams at the base of dome with M25 and Columns with M25.

While field measurements, lesser strength was observed in the Radial Beams. Hence the design of the Radial beams was specifically verified. As per numerical analysis, the reinforcement requirement for tension is 1600 mm^2 , whereas, the reinforcement provided for the same as per drawings is 1875 mm^2 . As per the results from Profometer tests carried out on slabs, the reinforcement provided is as per the approved drawings. Hence it is presumed that the reinforcement provided in the beams also is as per drawing.
