#### <u>വള്ളിക്കന്ന് മണ്ഡലത്തിലെ പാലം നിർമ്മാണത്തിന് ഫണ്ട് അനുവദിക്കാൻ നടപടി</u>

The AS proposal for the work "Construction of Irumbothingal bridge across Chalikkal thodu on Koottumoochi - Athanikkal road in Vallikkunnu LAC in Malappuram District"submitted by the Chief Engineer, PWD Bridges amounting ₹1244 lakhs is examined in general and the following observations are noted.

HARIKUMAR S CTE & EX-OFFICIO SEC (INSP TECH,FIN) <u>Note # 46</u>

The proposal submitted by AD for Rehabilitation of Kadalundikadavu Bridge -Rehabilitation of Kadalundikadavu Bridge in Beypore LAC and Vallikunnu LAC in Kozhikode and Malappuram Districts - phase-1 (Superstructure) amounting to ₹10.47Cr is examined in general and the following observations are noted based on the detailed estimate and report of KHRI furnished by the field officials and inspections conducted by FIW Tech officers.

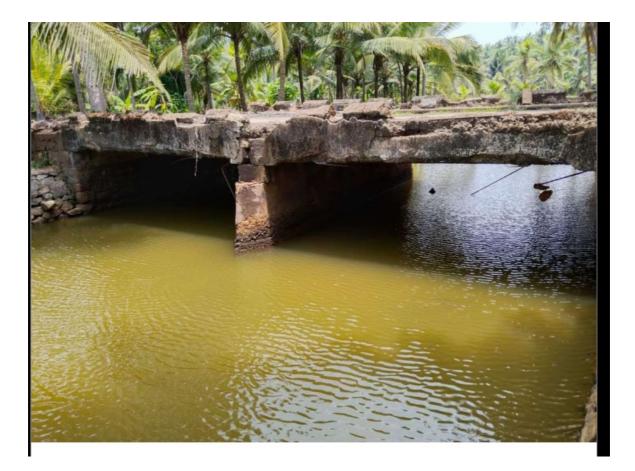
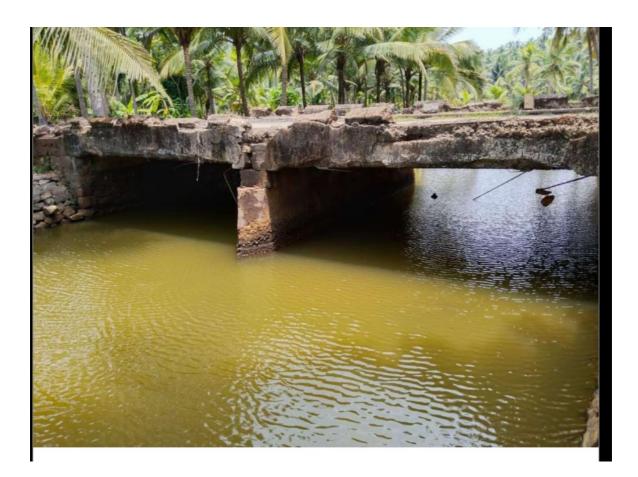
The existing bridge length is a single span of 11.20m , whereas the proposal is for a three span of 36m bridge.

<u>Photograph of the existing bridge showing its dilapidated</u> <u>condition</u>

4. In view of the above, we may limit the provision of approach road @50% cost of the approach road provision for issuing AS purpose only considering the dilapidated condition of the bridge.

- 2. AD may be advised to review the current proposal considering the option of a submersible type bridge at a lower cost considering the site conditions since the raising the existing level of bridge by +0.55m, the raising of the entire structure by 2m is observed highly uneconomical. Also the purpose of raising bridge at a higher level doesn't serve the purpose in a flood situation since one approach of the bridge is at a lower level.
